Manhole Inspection Summary

Manhole # S21A1_012MH

Insp Date: **6/17/09 7:29 AM**

Location Address: **2200 HOLLINS FERRY RD.**

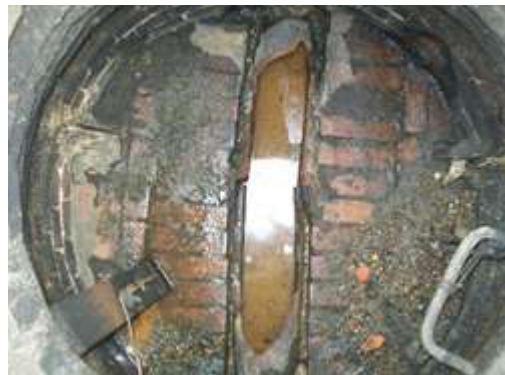
Top View

TOP VIEW AFTER SURCHARGE WAS RELIEVED

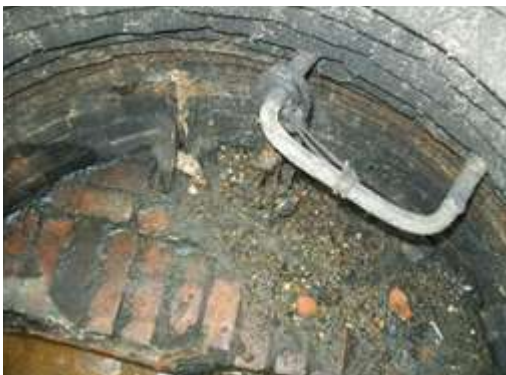
Miscellaneous

BENCH DEBRIS

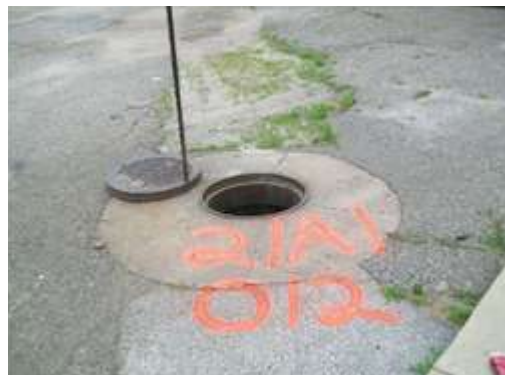
Miscellaneous

PAVEMENT MARKINGS

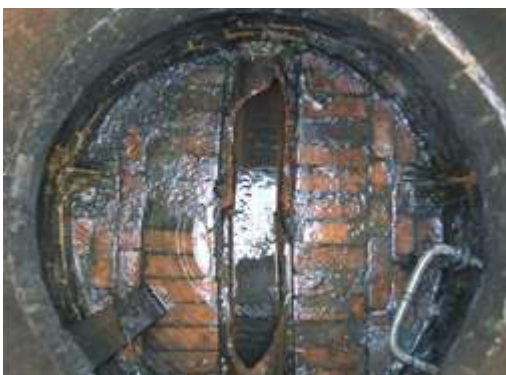
Miscellaneous

Surcharge ☒ **Evidence Of Surcharge** Depth: **2** (ft.) ☐ Active Surcharge Present

surcharge evidence

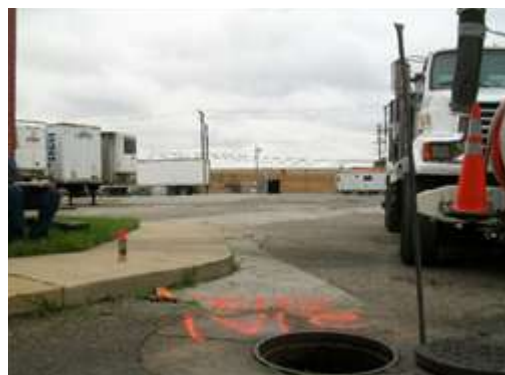
Defect 1

Cover Shape: **Circular** Diameter: **24** (in.) Length: **0** (in.) Dist A/B Grade: **1** (in.)

cover above grade 1"

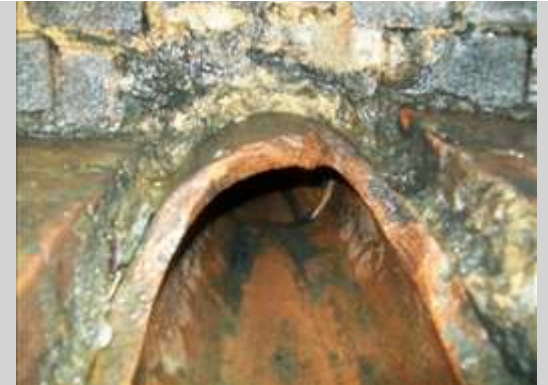
12 O'Clock Outflow

8 in. Circular Gravity Sewer
Pipe Out @ 12 O'Clock

Pipe Height: **8.4** (in.) Rod and Bar (Angled)
Pipe Material: **Clay** ☐ Pipe Lined
Invert Depth: **5.25** (ft.) Flow Characteristics: **Slow**
Deposits: ☒ None ☐ Mud ☐ Sludge ☐ Debris ☐ Grease
Silt Depth: **0** (in.) Deposits Extent:
Infiltration: **Evidence** Pipe Seal Cond: **Sound**

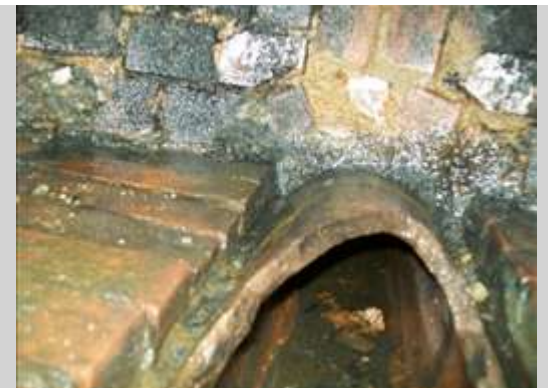
6 O'Clock Inflow

8 in. Circular Gravity Sewer
Pipe In @ 6 O'Clock

Pipe Height: **8.4** (in.) Rod and Bar (Angled)
Pipe Material: **Clay** ☐ Pipe Lined
Invert Depth: **5.16** (ft.) Flow Characteristics: **Slow**
Deposits: ☒ None ☐ Mud ☐ Sludge ☐ Debris ☐ Grease
Silt Depth: **0** (in.) Deposits Extent:
Infiltration: **None** Pipe Seal Cond: **Sound**
